SAAB AT KEBNEKAJSE: COLD CLIMATE TESTING IN SOME OF LAPPLANDS COLDEST REGIONS!

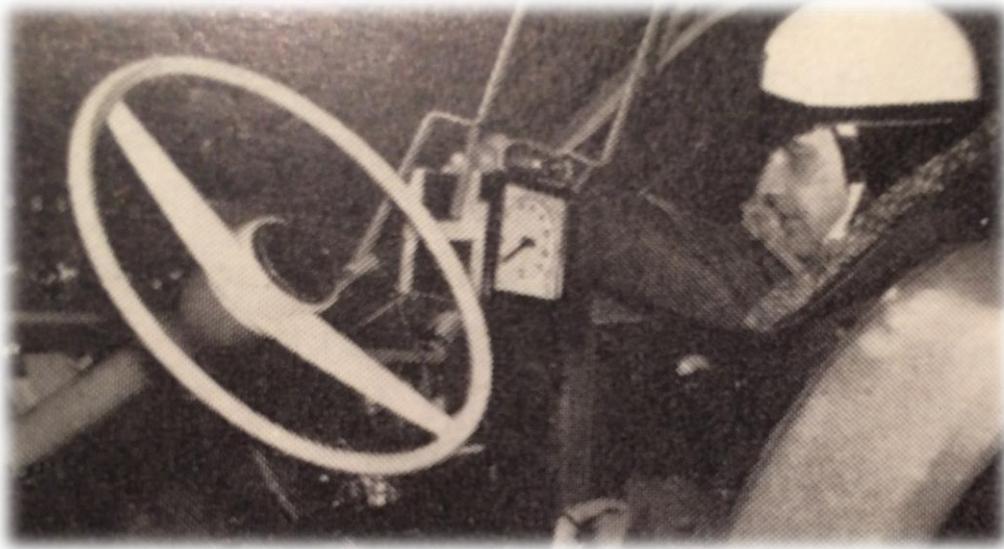
The cars extra equipment included a specially installed temperature gauge to record ambient temperature – here engineer Kjell Kristiansson records an ambient temperature of -26°C at the start of an early morning ‘cold start performance’ test.

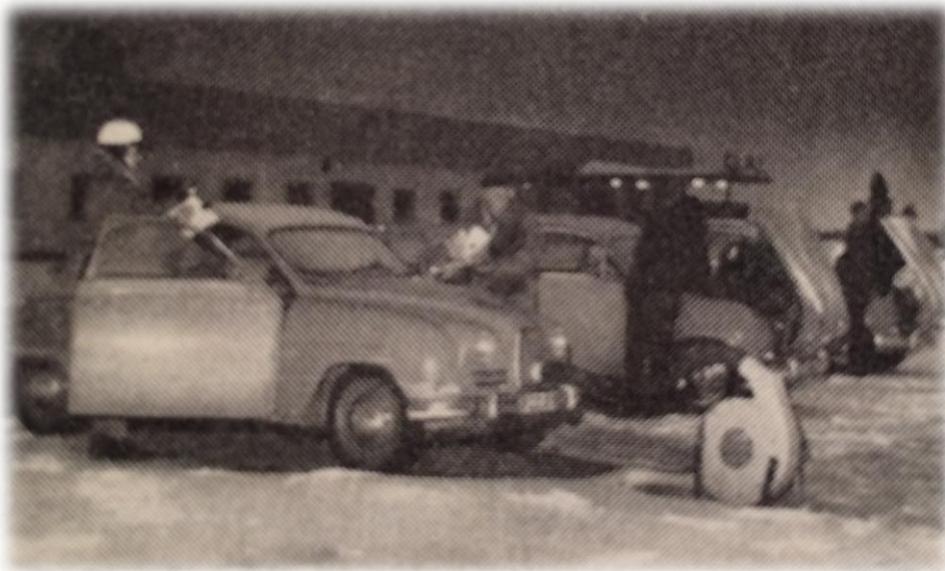
Cold start schedule of the three test cars at -26 °C.

Early morning at the winter test facility: Three test cars have been “soaked” all night in -26°C and are ready to be evaluated for starting performance.

Test Engineer Kjell Kristensson (in white helmet) is almost ready to start the first test car and its drive away performance - note the check list he holds to record initial temperature values from several engine and interior measurement points etc.

It may look like a heater unit in front of the first car, but in fact it's a special fan used to blow cold air through the cars grill into the engine compartment.

Mechanics can be seen in the photo 2 above, presumably fitting a warm charged battery in the remaining two test cars.

At sub-zero temperatures, a car battery state of charge becomes greatly reduced and can struggle to crank the engine -Hence most testing is done with a battery that has been stored during the night in the warmth of the test facility.
